Diarizos Sites Status: February 2019

Introduction:

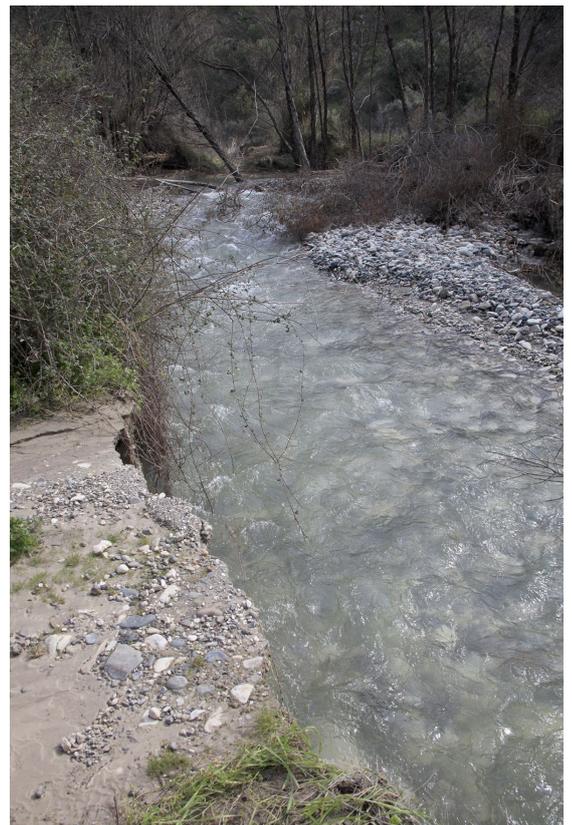
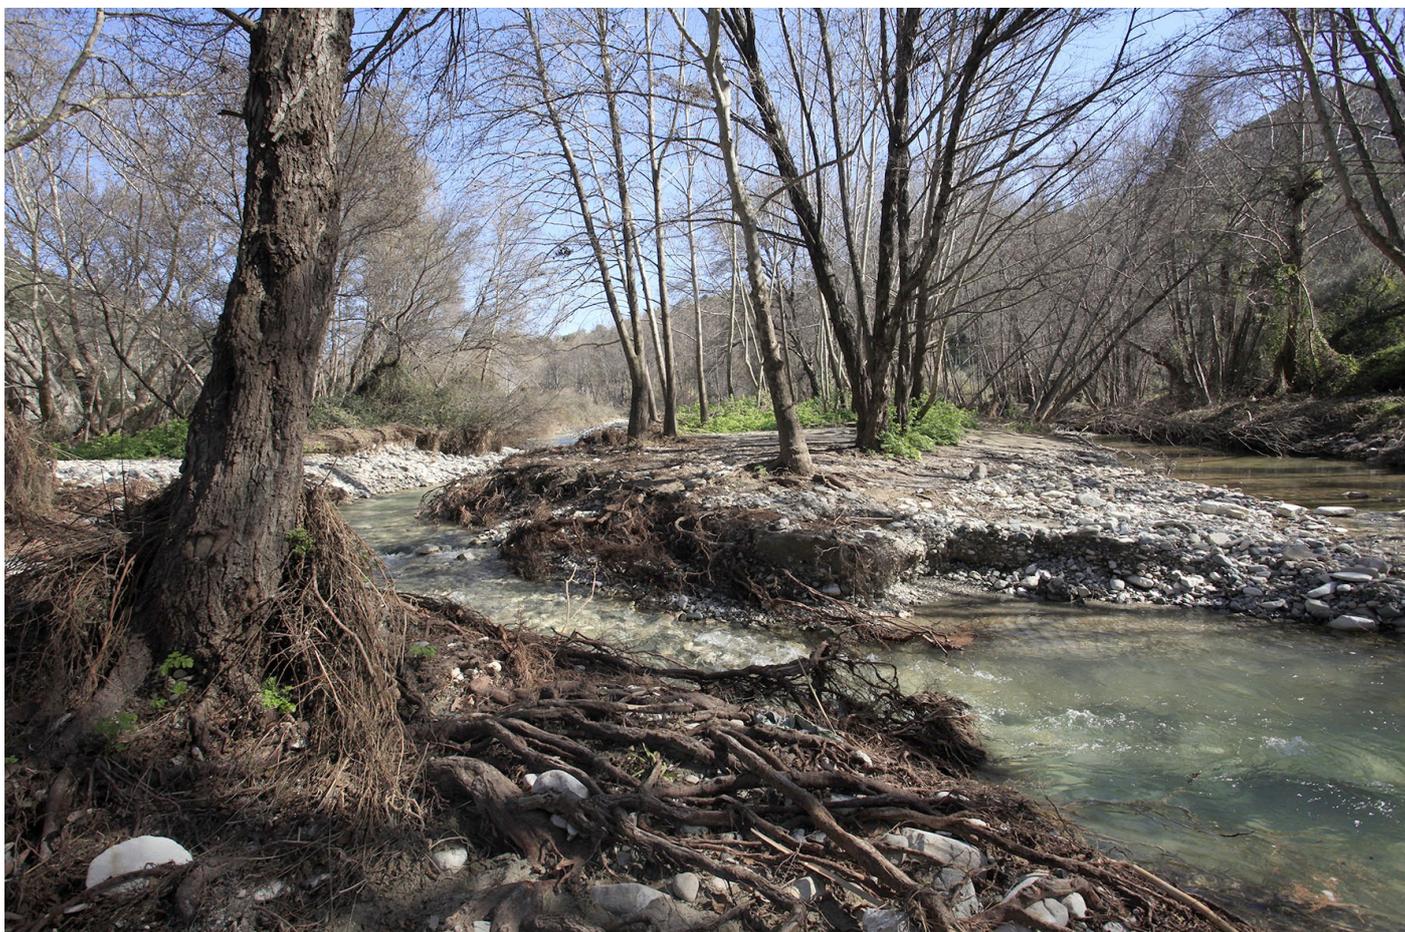
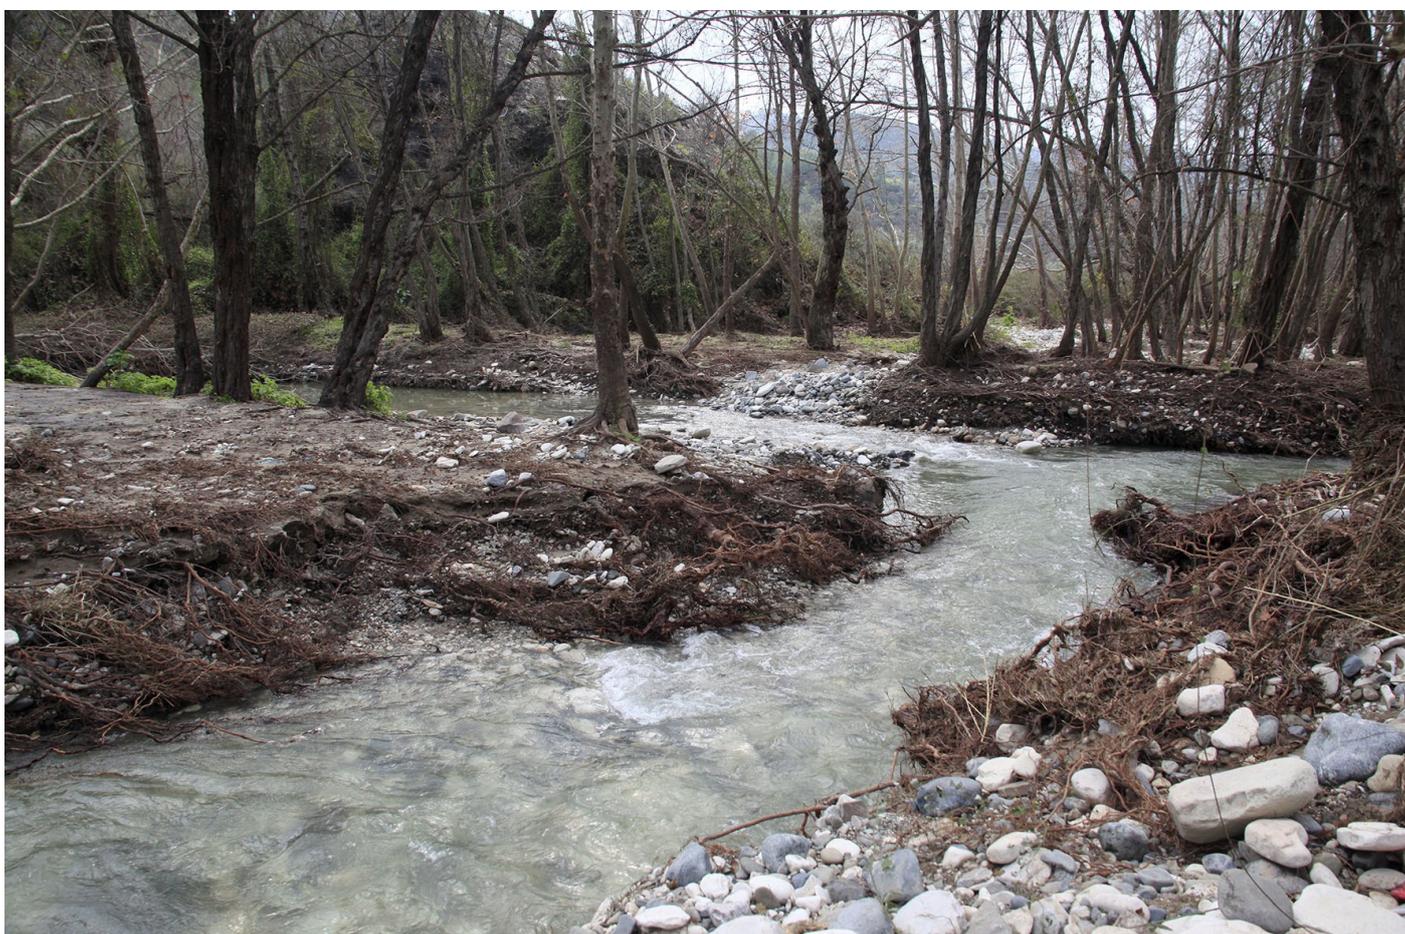
However by 22nd January the site had been transformed. The whole picnic area was covered in stones brought down by the flood. The banks had been scoured and a lot of vegetation destroyed—but fortunately the trees seemed to have survived. Surprisingly although there were no physical obstructions such as reeds in the original course, the river had carved out an additional new channel along what was previously the track through the site (upper photo on next page). As a result the track down from the upstream side of the large rocks now ends in a precipice with a torrent below (see photo right). The new and the original channel then converge at the start of the picnic area (lower photo on next page).

It is assumed that the river chose this new course since, with no vegetation to stabilise the soil, the track through the site offered the path of least resistance. Interestingly on 5th February the flow was stronger through the newly-created channel than the original one.

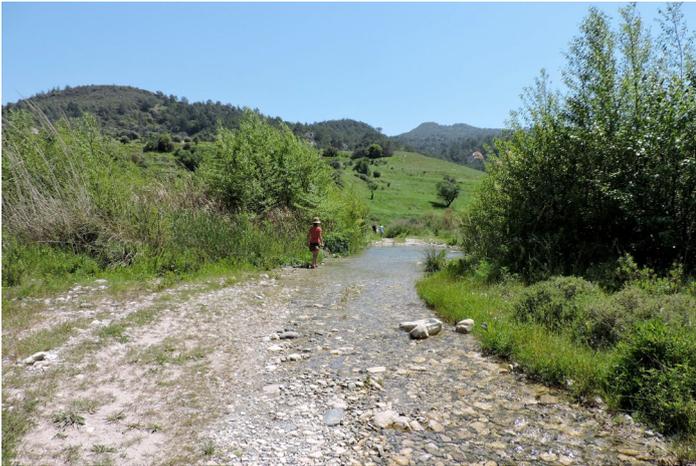
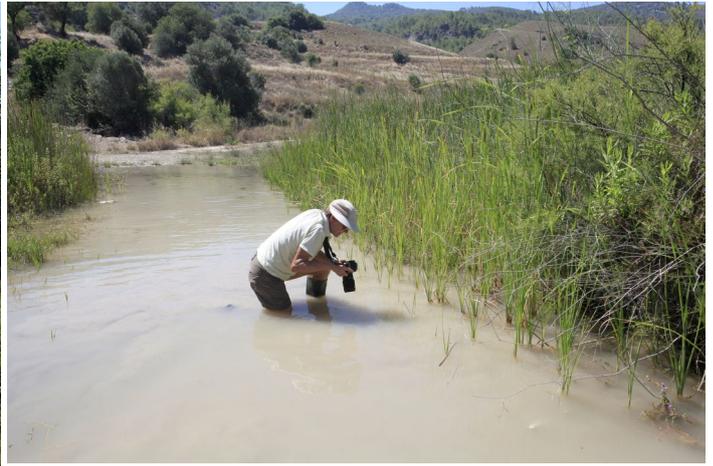
This site is located below the large rock that can be seen from the Extreme View Café. In most years during the rainy season, the river here had already spread out creating several flooded areas. The image on the left above was taken in April 2015 and the image on the right in June 2017.

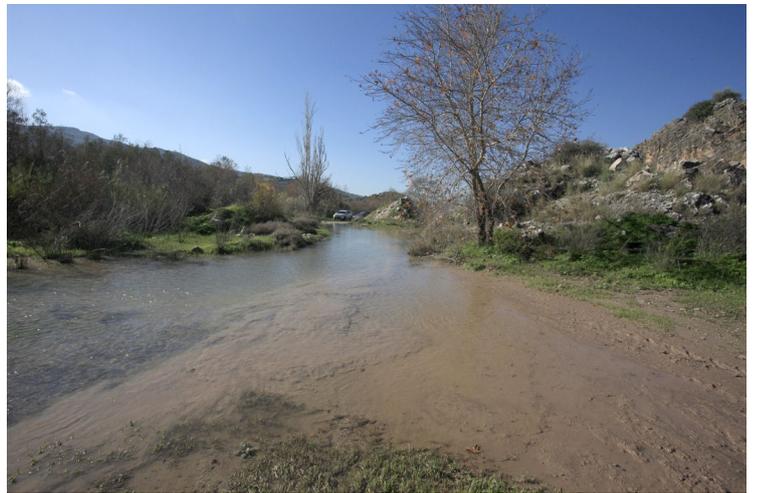
During most rainy seasons there has been a large overflow pool on the access track, beside which we usually park. As would be expected, this was quite extensive earlier this year as shown in this image taken on 12th January.

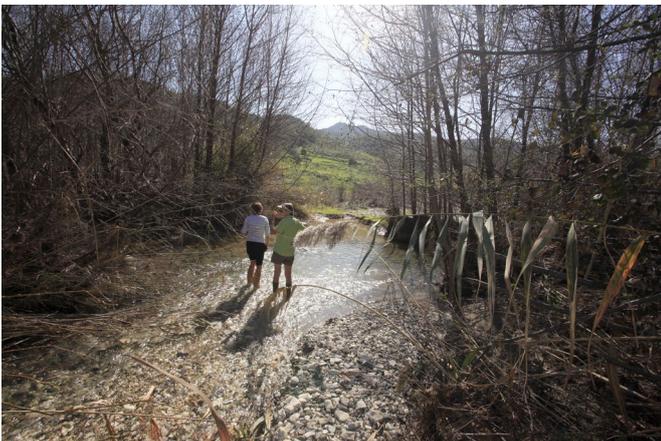
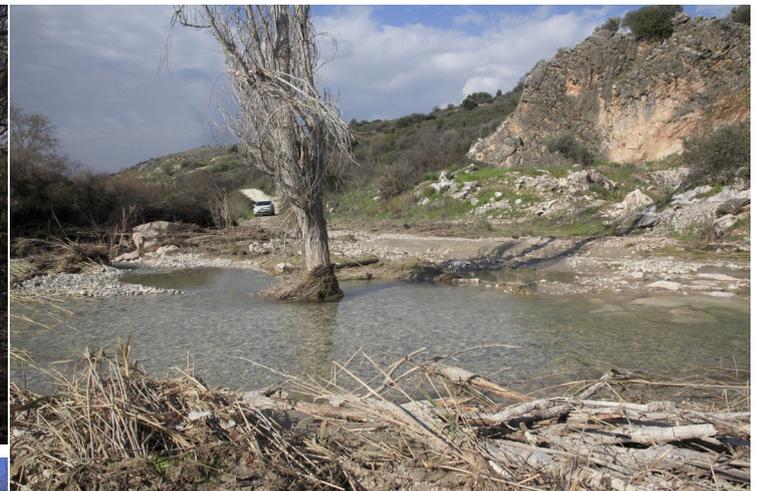
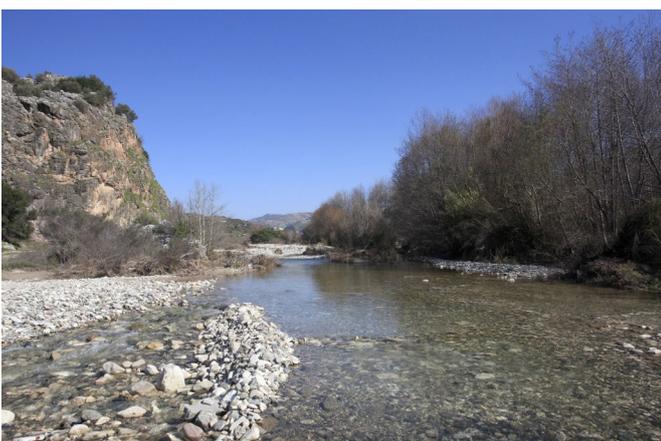
Following the flood, the river has opened up several channels and water is now flowing through at least five of them. The main ones are the channel near where we usually park and there is another on the other side of the stream complex.

This has been an important site for dragonflies in the past. The vegetated area in the middle of the valley, which previously formed the main river bed, seems to have been spared the worst of the flood. So hopefully there is a chance that larvae may have survived in this location.

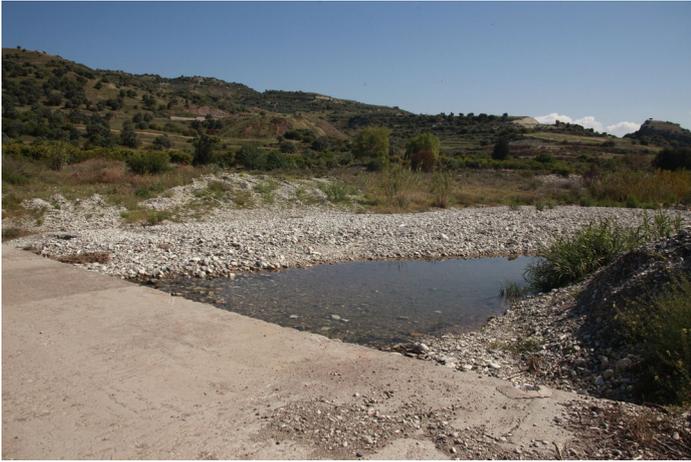
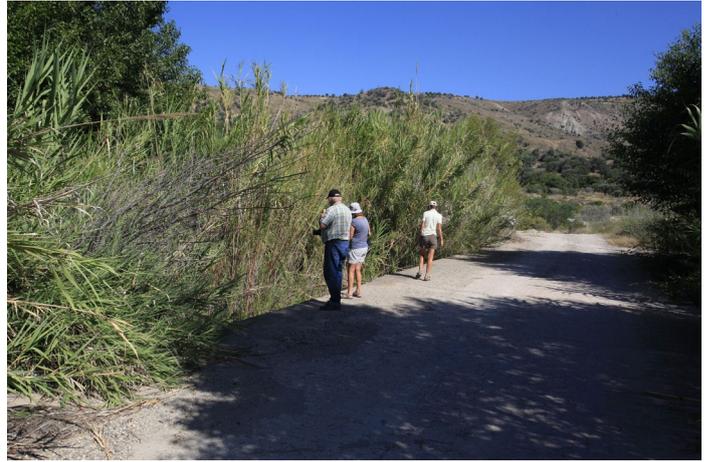
These two adjacent sites have been important and the most species-rich sites on the island. When monitoring started in 2013 the river bed was free from reeds (*Arundo donax*) (left hand image above) and the sites remained relatively reed-free until October 2015, when vegetation started to encroach on the watercourse. D1 was particularly badly affected and by late 2016 was fully choked. D2 was slightly better with some open areas. Image on right shows D1 in June 2018.

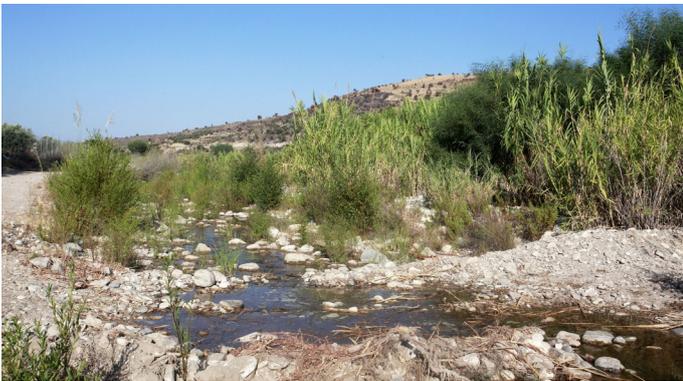
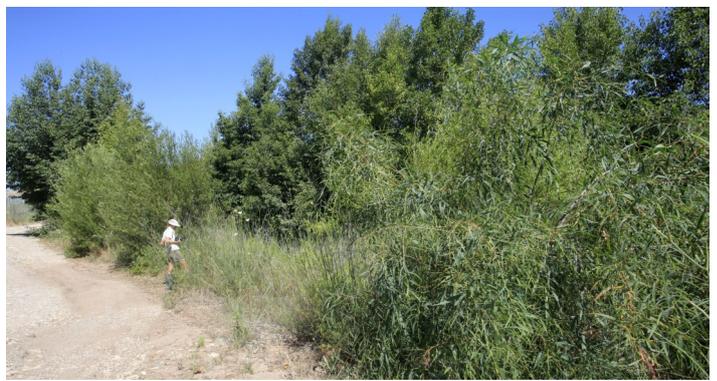
The above left hand image shows D2 in August 2014 and the left hand image in June 2018. When visited on 12th January 2019 the flow on the river was strong and some of reeds had been swept away. There were some open spaces between the two transects which looked quite promising. On returning to the site on 22nd January, it was amazing to find that the whole area of the valley had been reshaped—"geomorphology rampant in the Diarizos valley", as Ros commented, having attended the Earth Sciences group. The valley floor was strewn with rock debris and the river was now running ca 100 m closer to the main road.

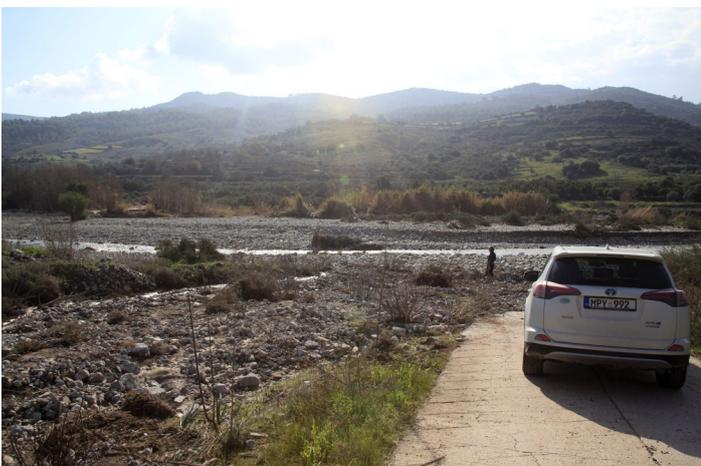
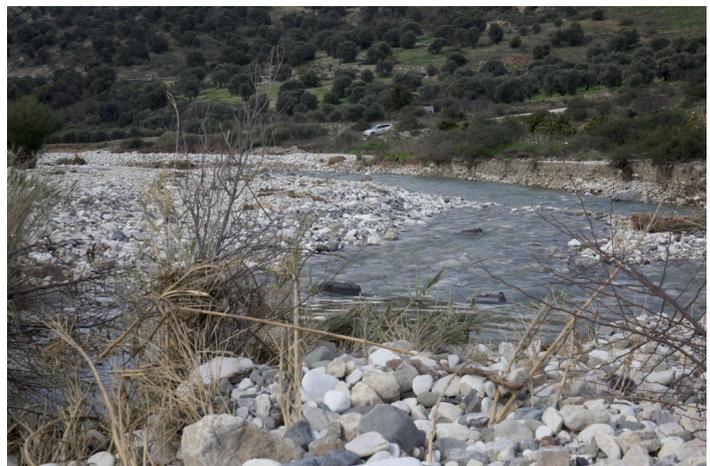
It was not possible to drive to the D1 site since the track at the end of the concreted part had been washed away and as can be seen in this image the river had shifted its course significantly. The original course was through the line of trees that can just be seen half way up the left hand picture. The right hand image shows just how dramatic the action of the water had been.

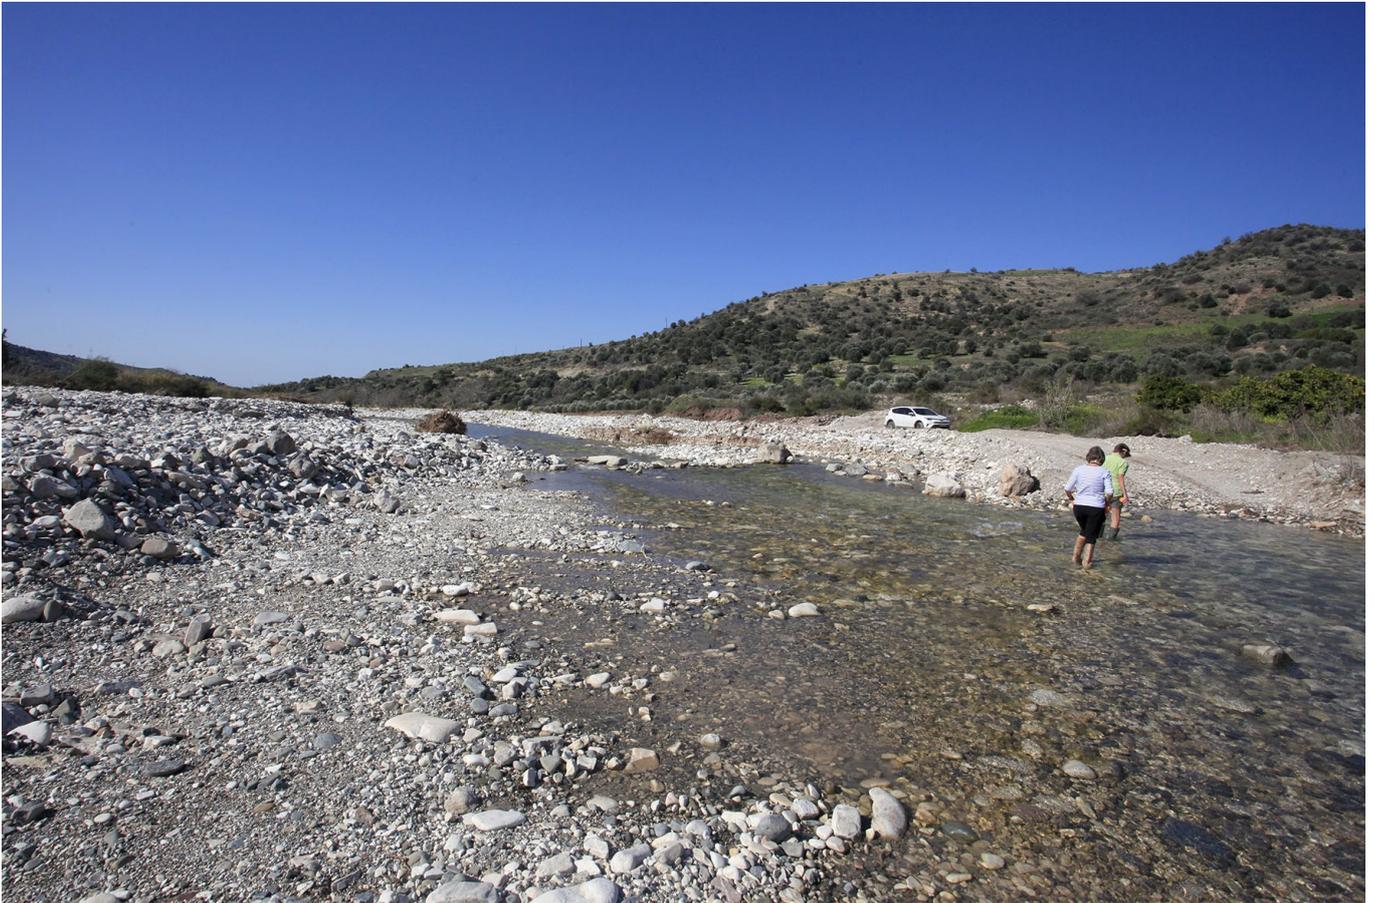
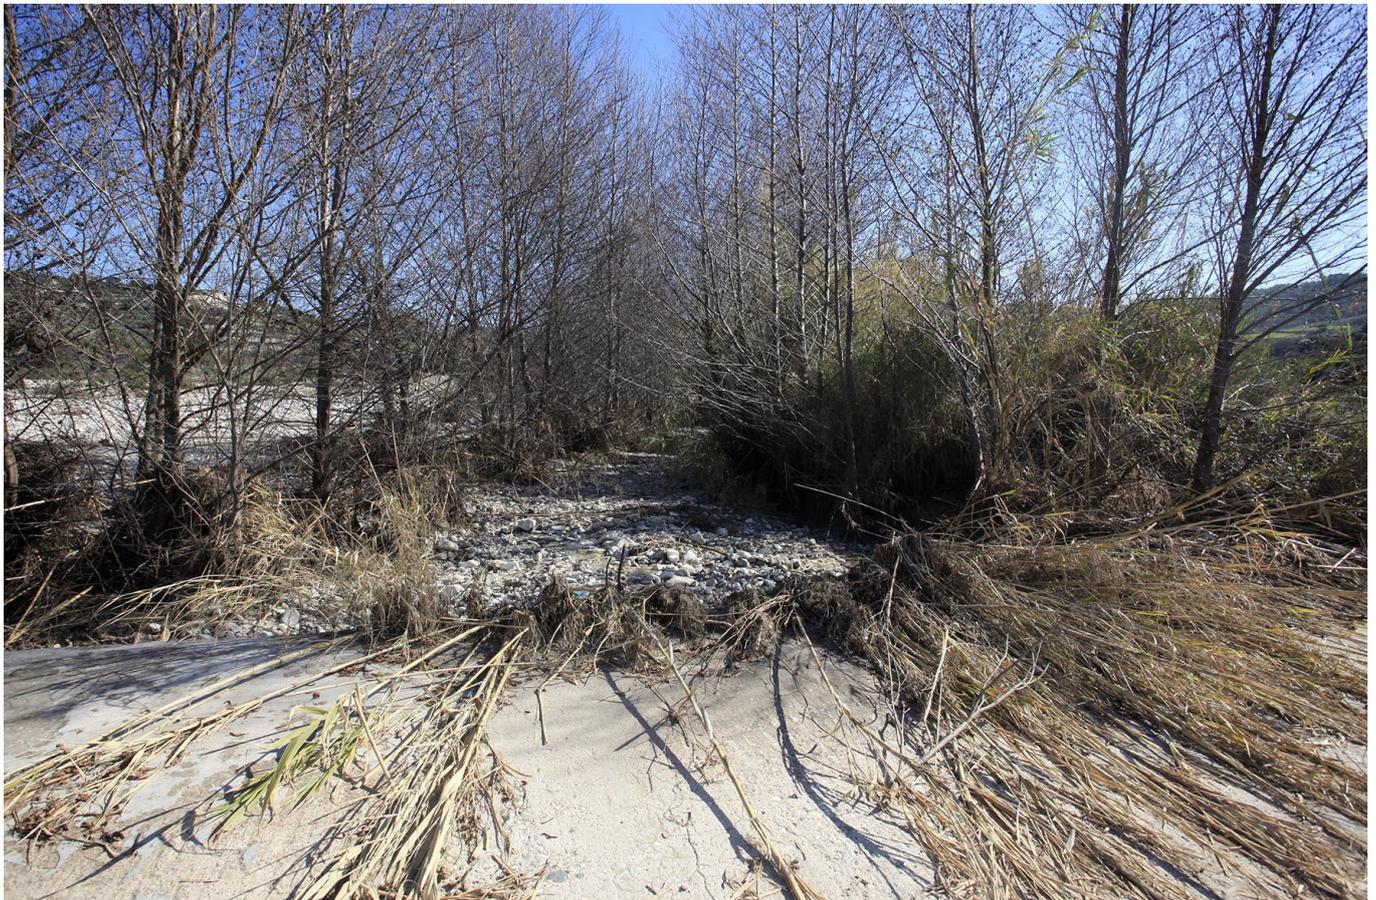
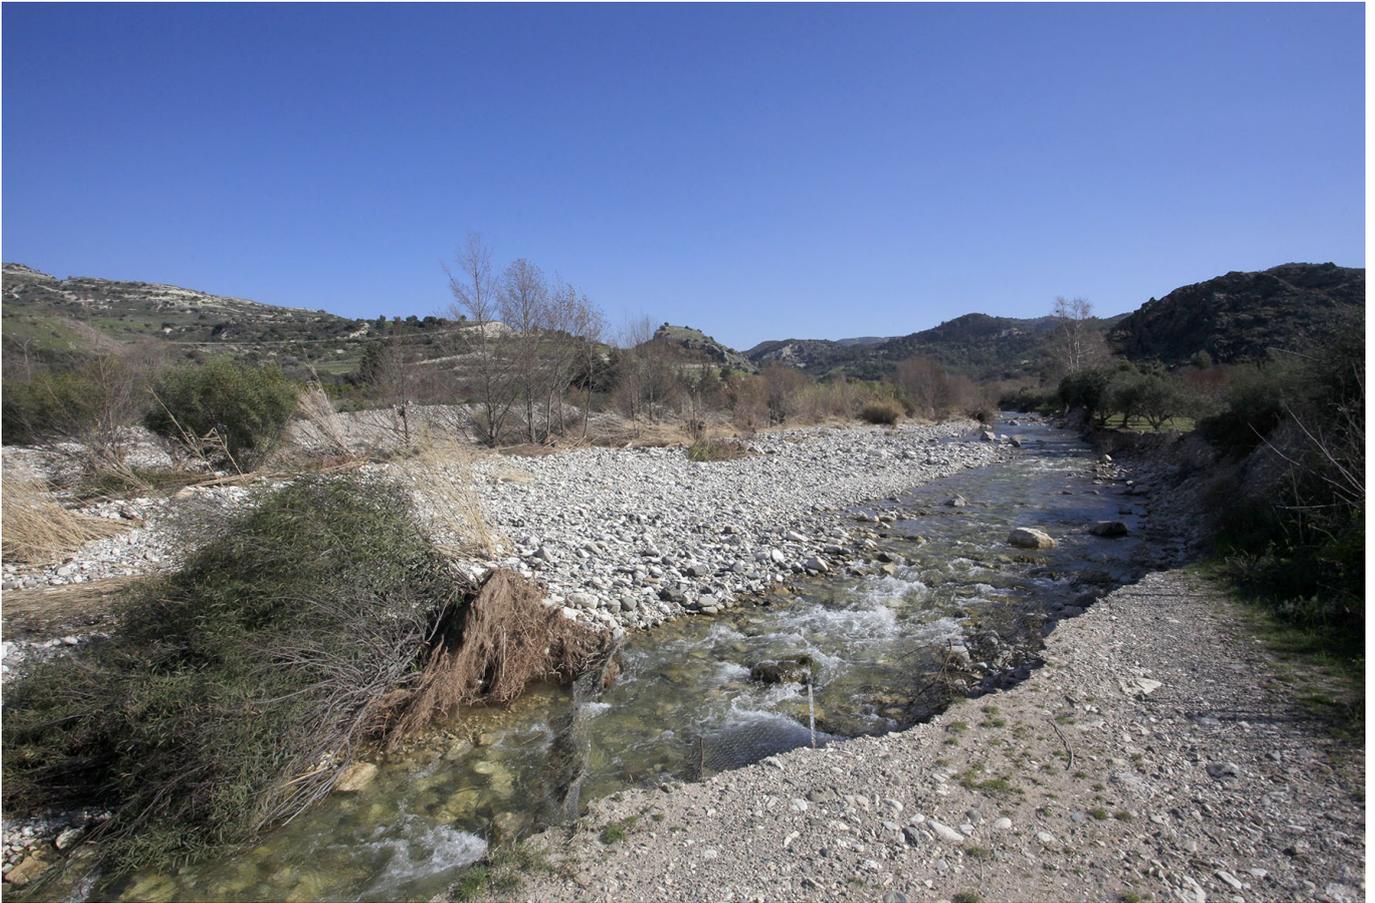
On returning on 5th February we found that access to D1 was now possible by car. A new track and ford had been levelled and rubble cleared off the tracks. We decided not to try driving through the ford and instead walked to D1. Two farmers had however made the crossing in their pick-up trucks. The bridge was still intact and, as would be expected, the reeds at D1 had been cleared as shown in the photo below taken from the bridge, but there was no flow of water—the river had been diverted! It therefore seems likely that D1 will be permanently lost.

From D1 we were able to walk only about 50 m towards D2: the rest of the track to D2 had been swept away and now formed the new course of the river. The upper image is a view towards D2; the furthest point that can be seen on the river was the place where we used to park the car. The vegetation in the top half of the photo marks the original course of the river. The lower photo was taken below the end of the existing track from D1 to D2.

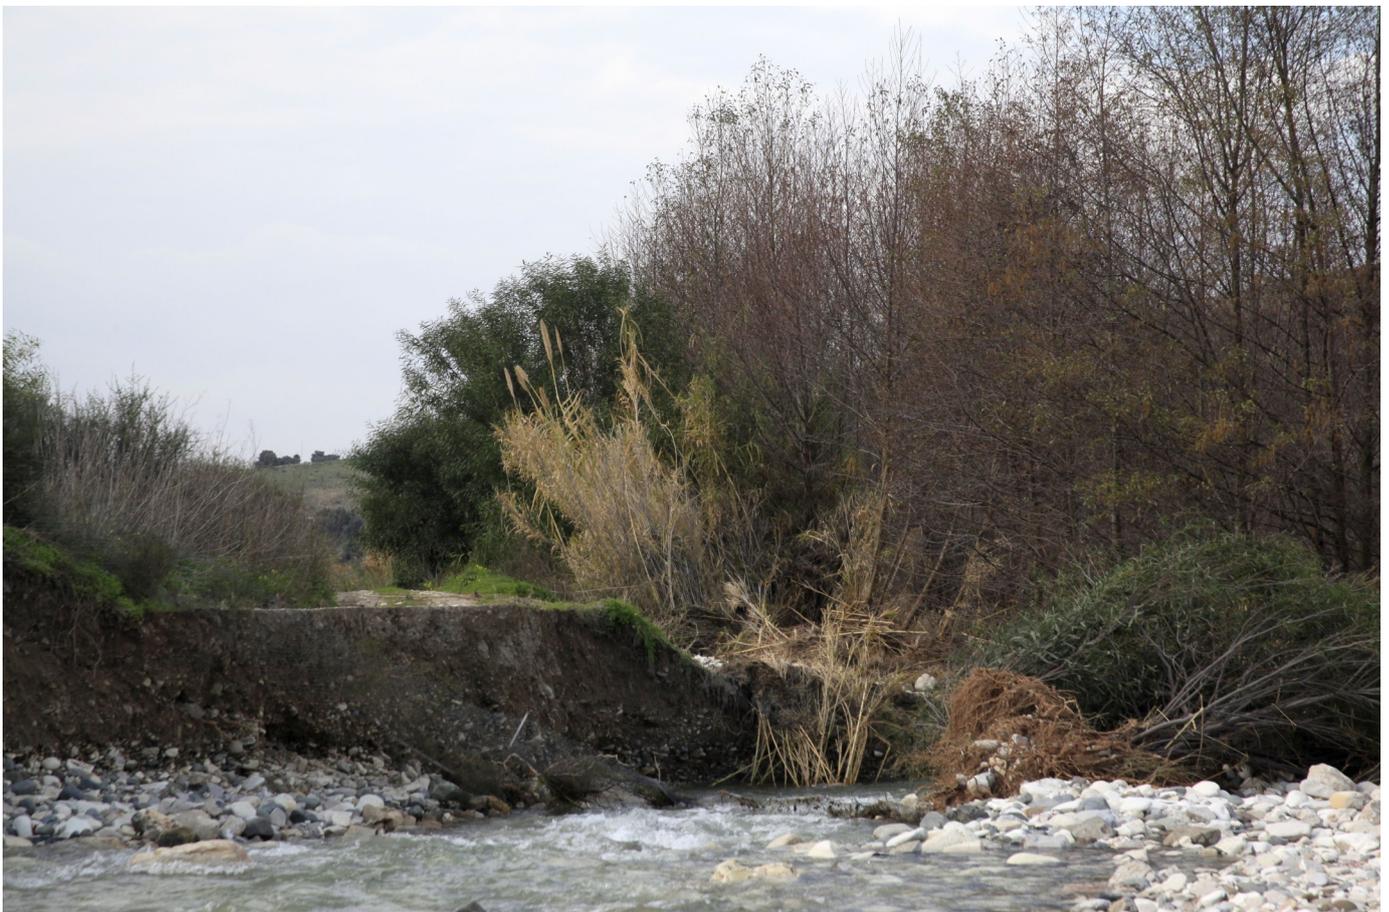
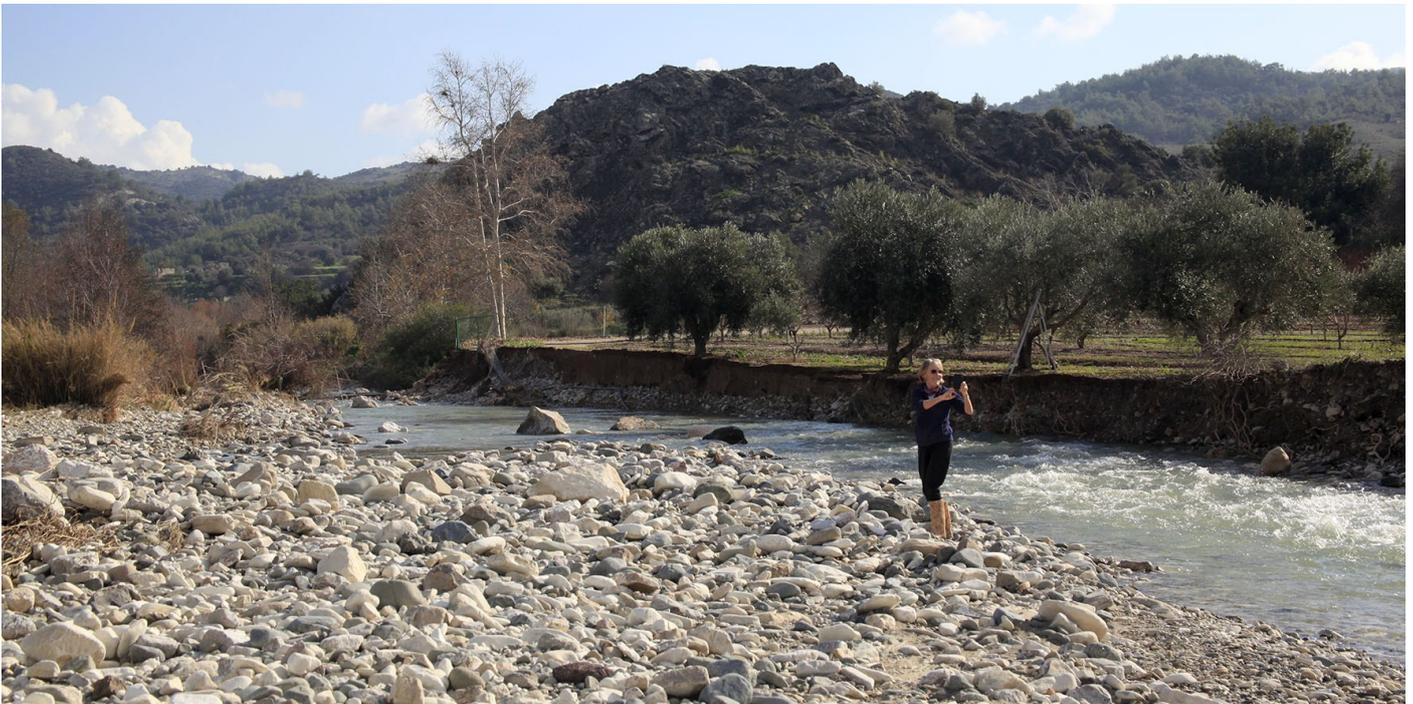
In carving out the track, the river cut deeply into its bank as shown in the photo above. Roger and Heather visited the site on 24th January and spoke to one of the farmers. He told them the lost track was the only access to his orchards and showed a video of the river in flood with water from one side of the valley to the other. He also commented that this was the worst flood in the valley since 1969. Checking on the Ministry of Meteorology website, 1968 - 69 was the last hydrometeorological year of extremely high precipitation (defined as $> 130\%$ of the normal level i.e. more than 654 mm). Another farmer they spoke to further downstream had lost six beehives. Part of the road to the bentonite mine at Kidasi had also been washed away, although this had since been bulldozed through to allow access.

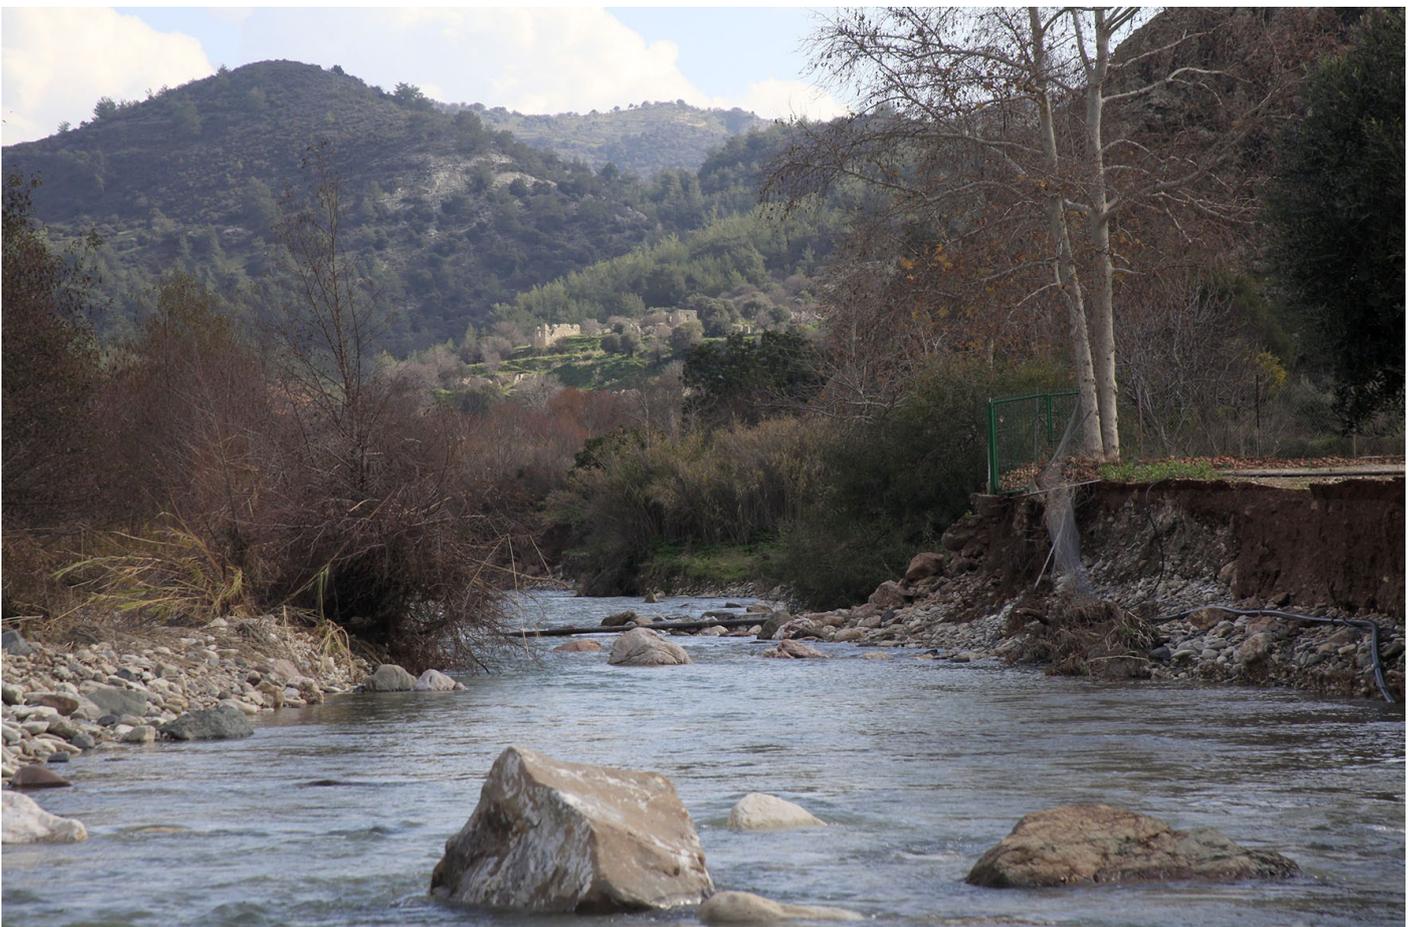
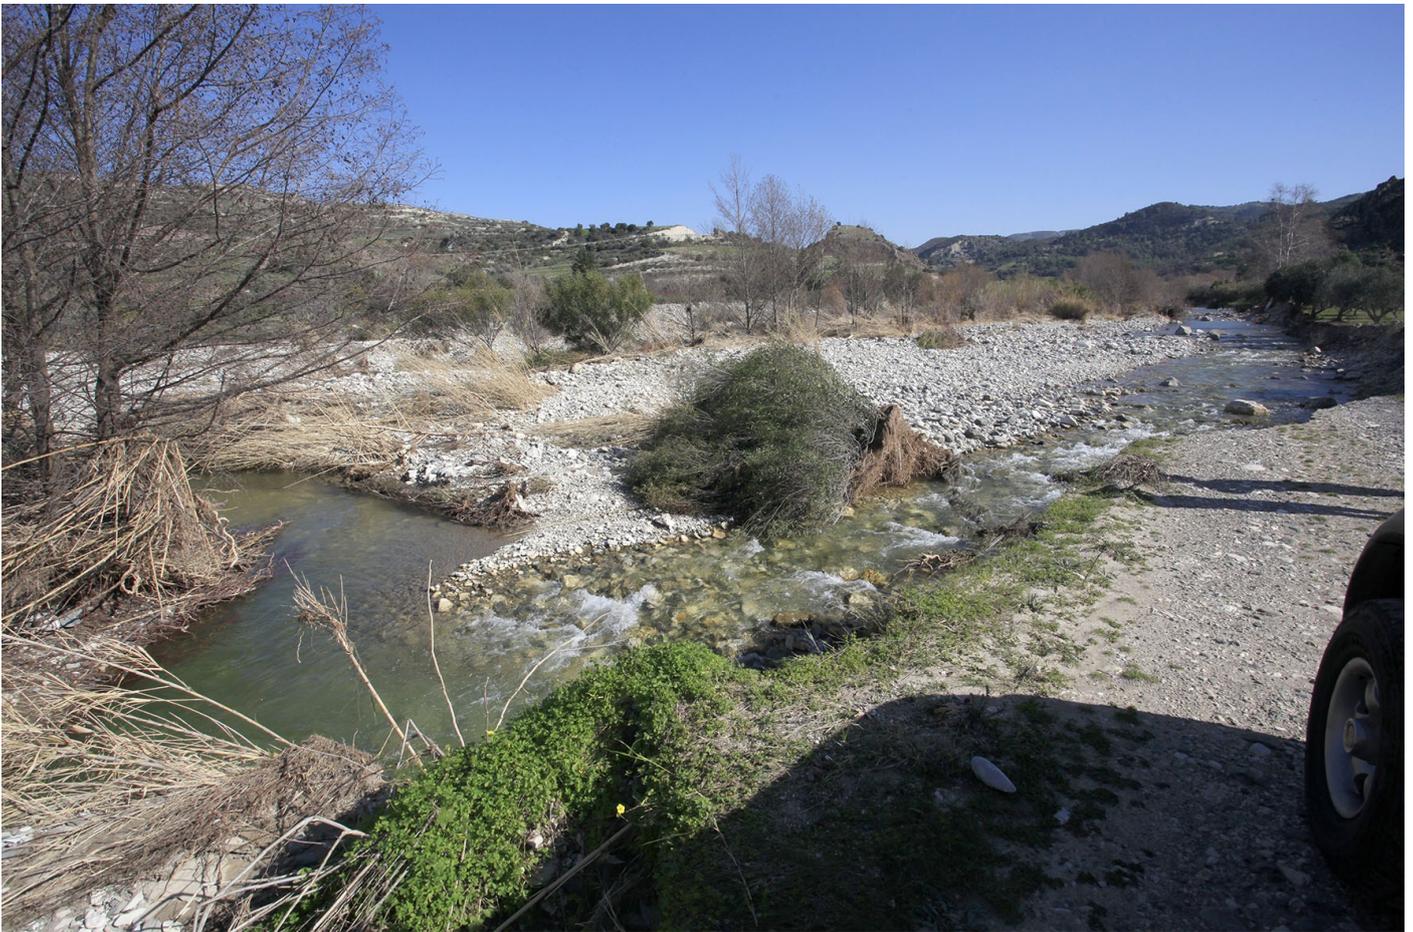
In the photo below some of you may recognise the green gate that was just before the parking spot for D2 - the track was previously only slightly below that level!

That is quite impressive, but then, remarkably, at the point where what is left of the D1 to D2 track ends, the river makes a sharp right turn as shown in the above photo. The probable reason for that is that the ground directly ahead is stabilized by the vegetation, especially tree roots and the river takes the course of least resistance as shown in the photo below.

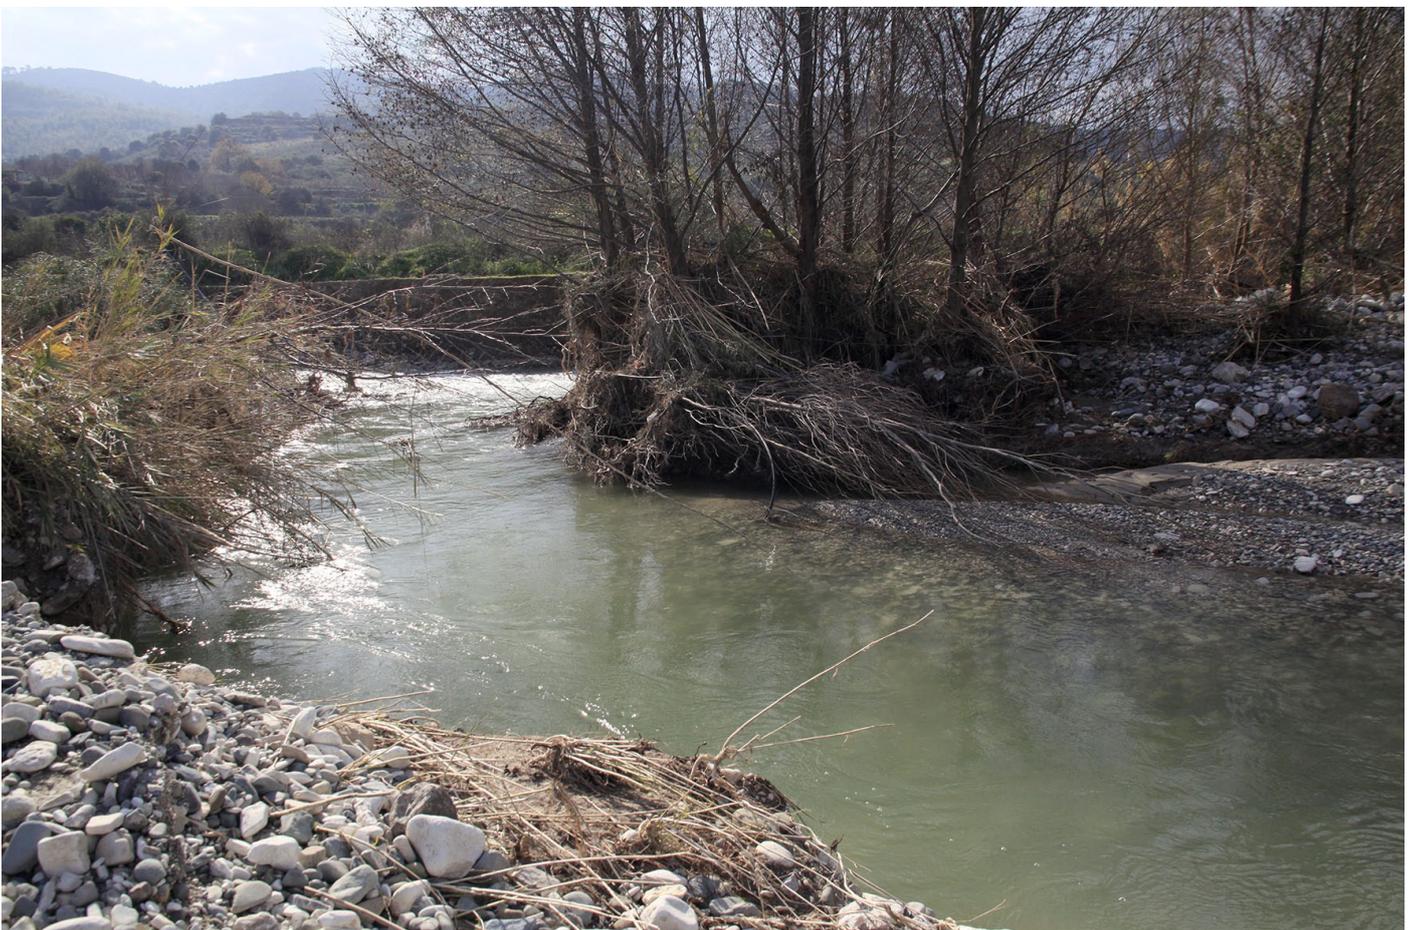
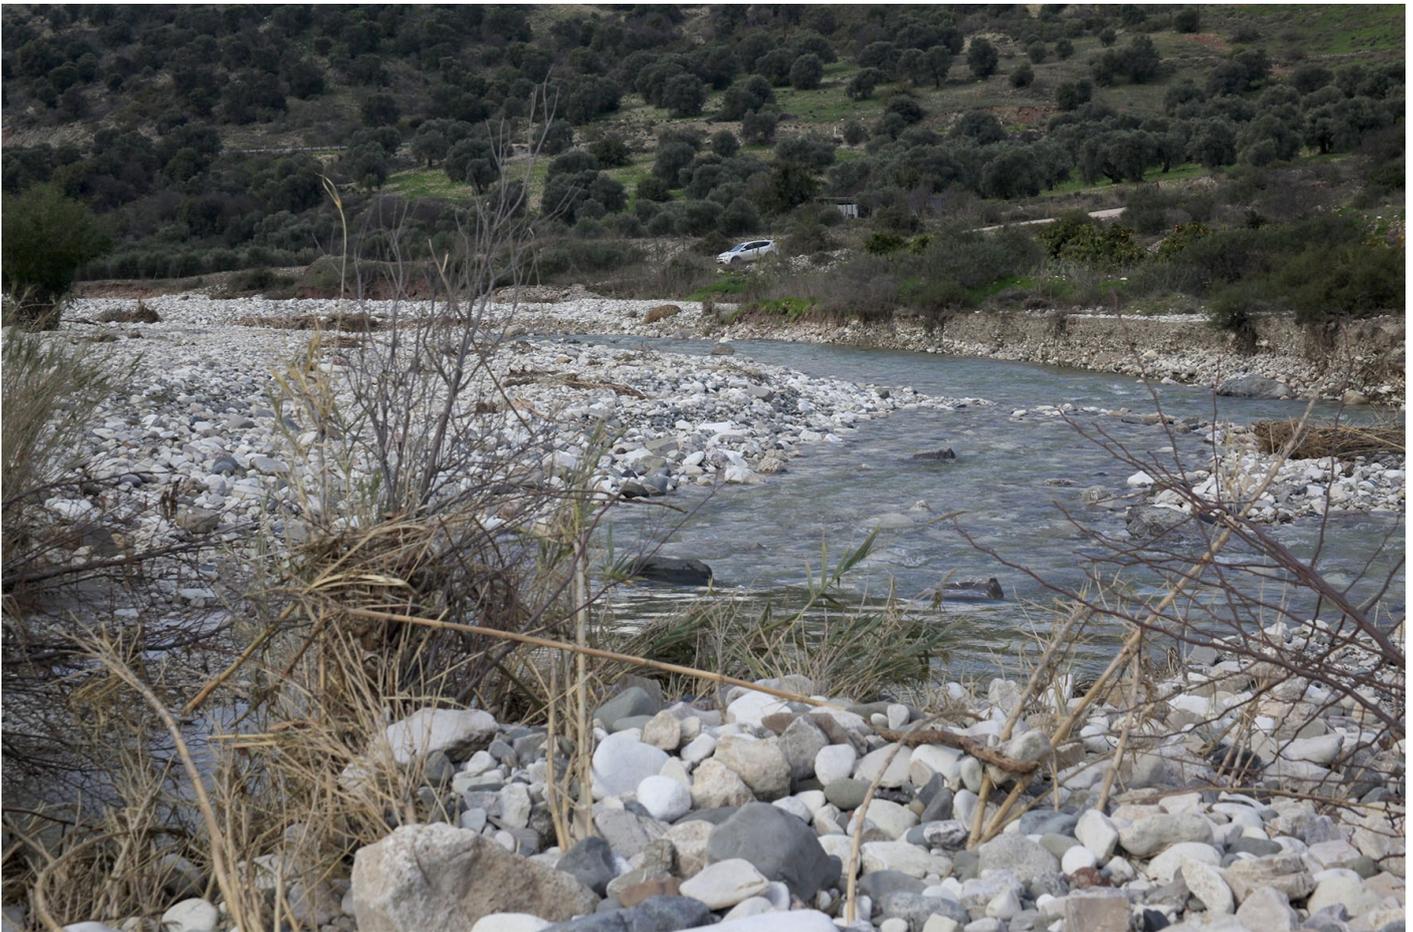
Having made the right turn, the river then selected the path of least resistance and cut a new channel into what previously was an un-vegetated track on the western side of the previous river bed. It then heads south towards the sea. On travelling up the valley we noticed for the first time that wherever we could see the river it had flowing water.

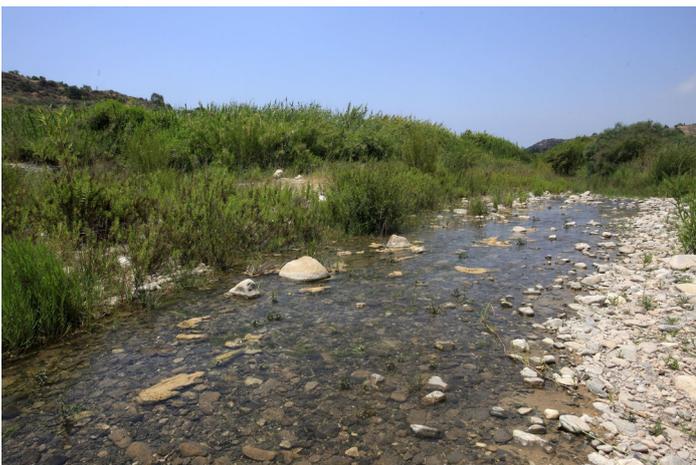
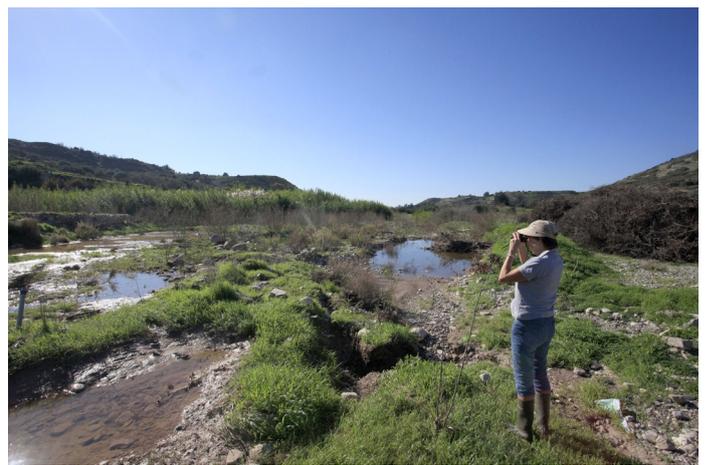
The above left hand picture shows Kouklia reed beds in July 2015 when there was still a steady flow on the river. Half way up the picture the wall of the small water storage tank (which had been empty since 2016) is visible. The photo on the right shows the site in December 2018.
