Diarizos Sites Status: February 2019

Introduction:

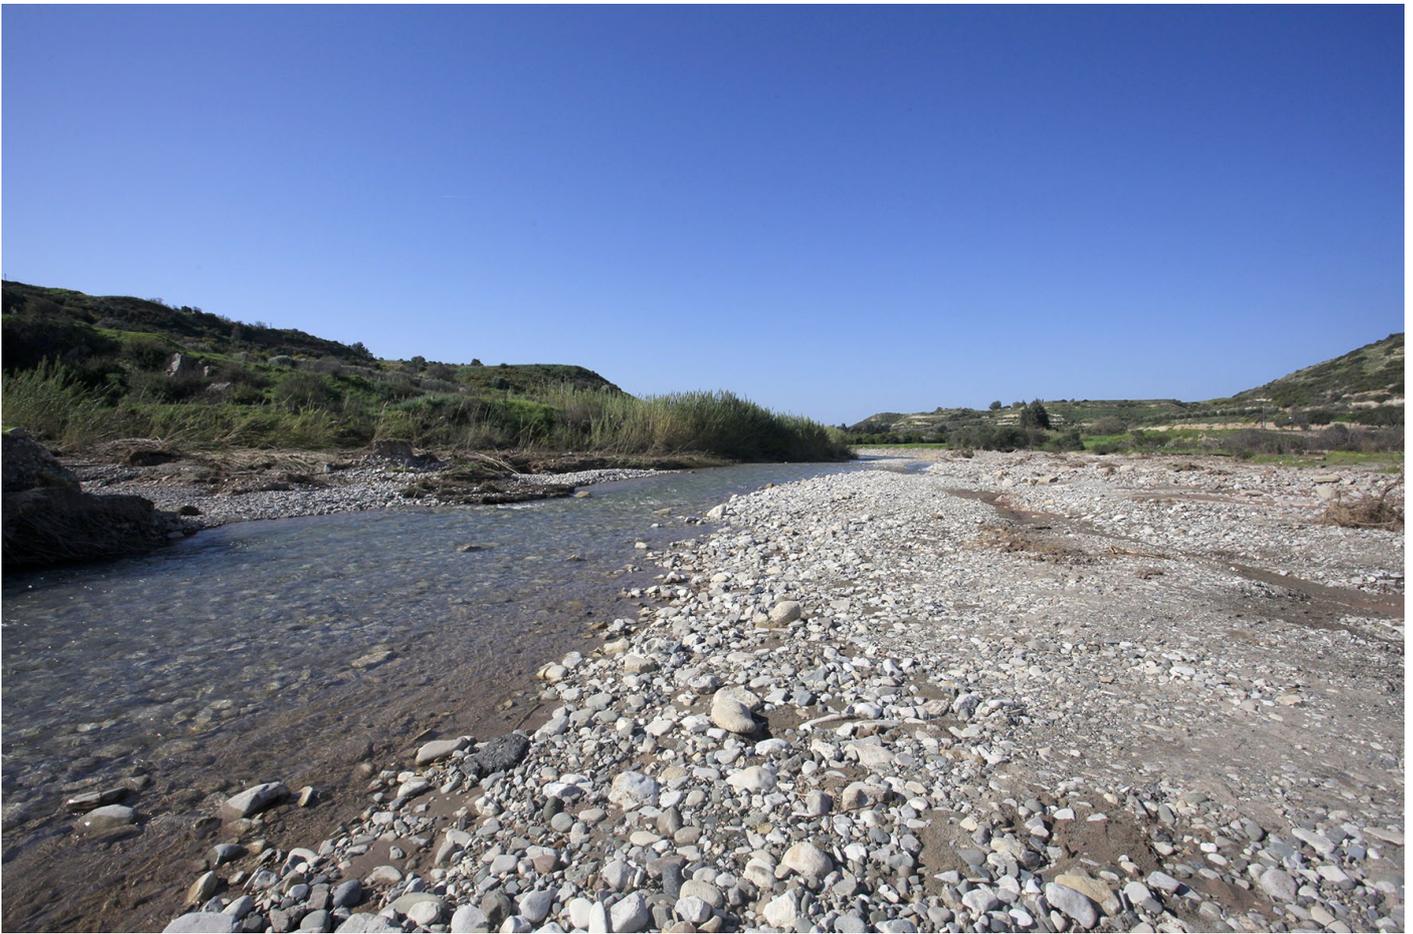
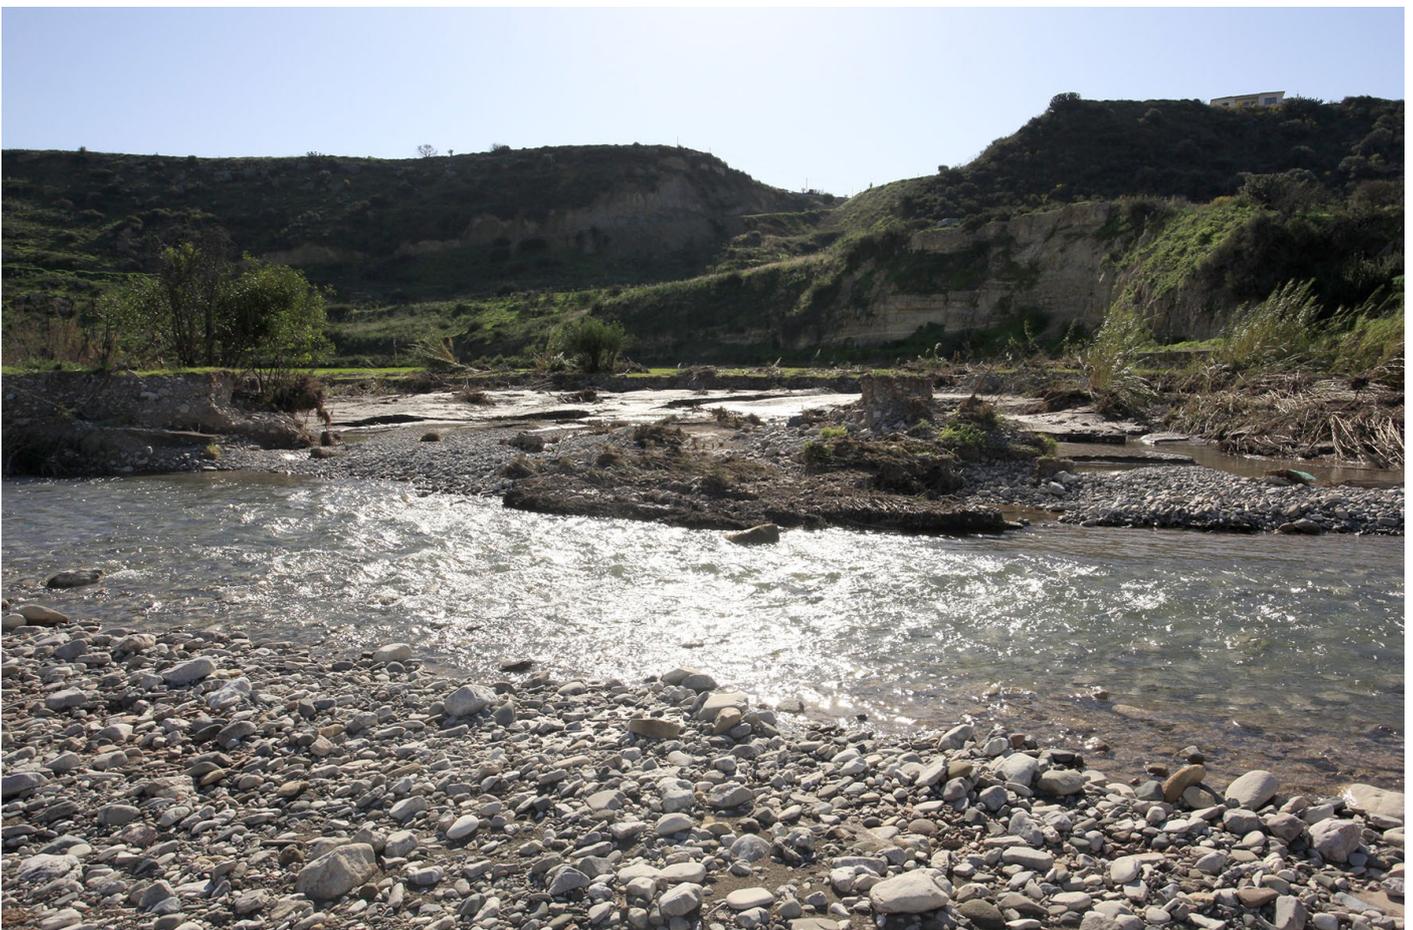
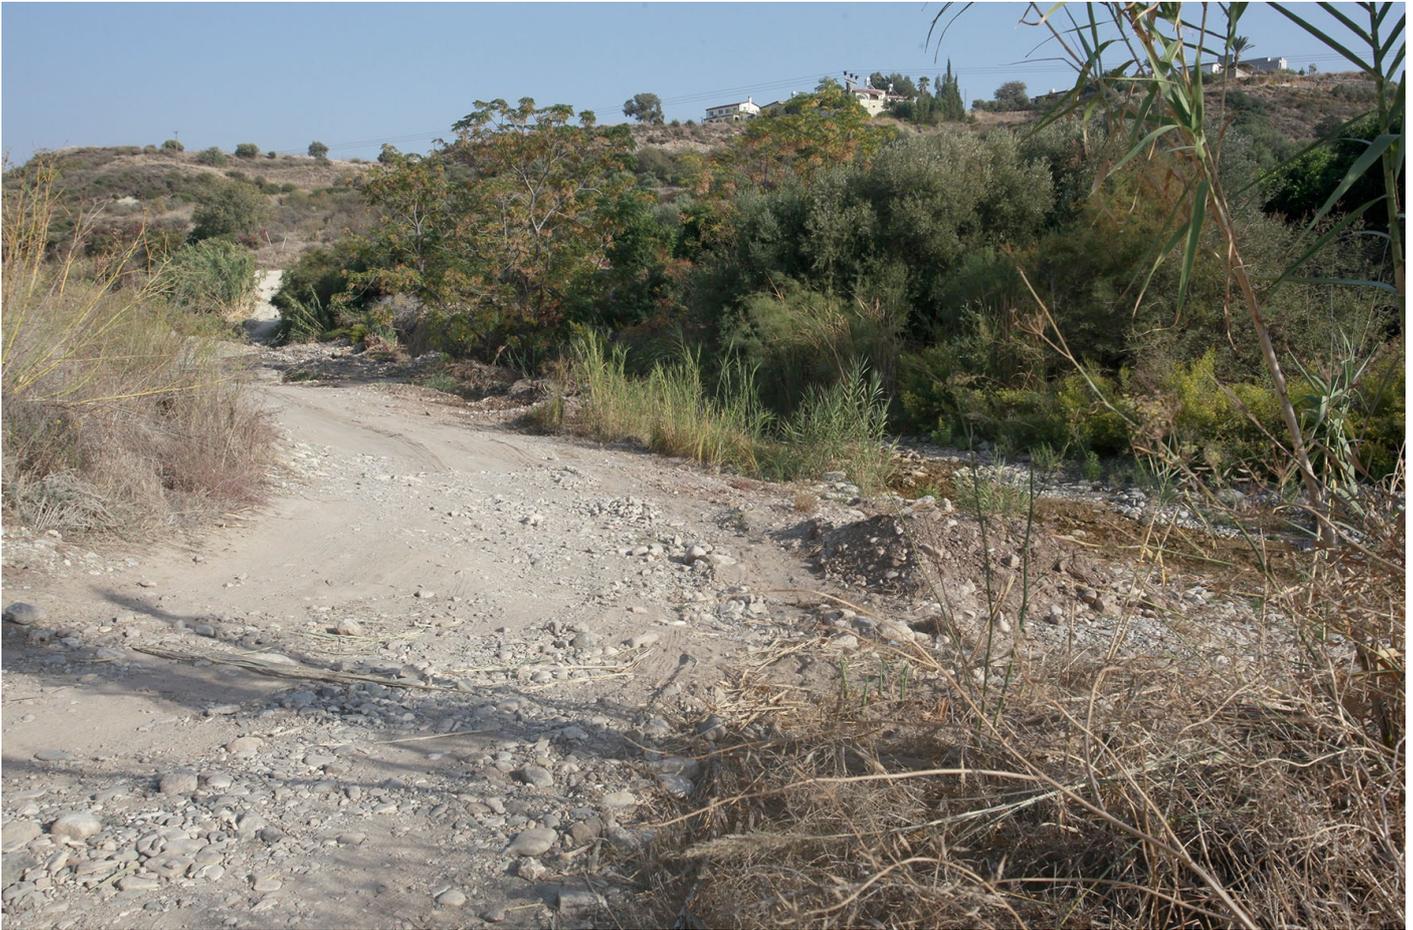
The photos on this page show the site on 5th February 2019. The valley had clearly been completely flooded. Vegetation on the river bed had been stripped and the whole area was strewn with rocks and stones. The access road had obviously also been flooded but had already been cleared. As shown in the lower photograph the upper and lower walls of the tank had been washed away. Unlike the previous sites, however, the river had remained on its original course.

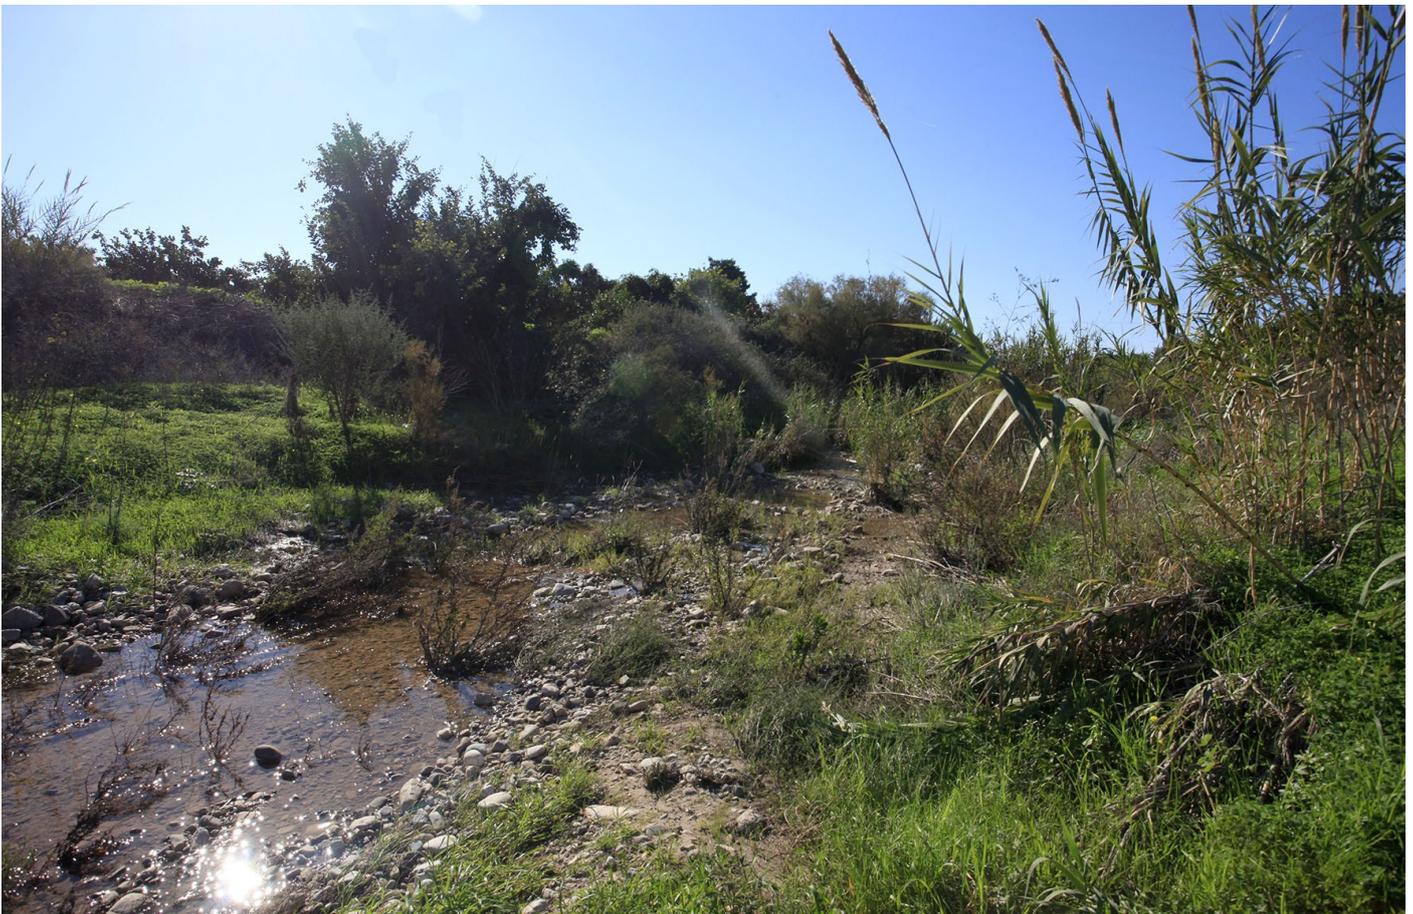
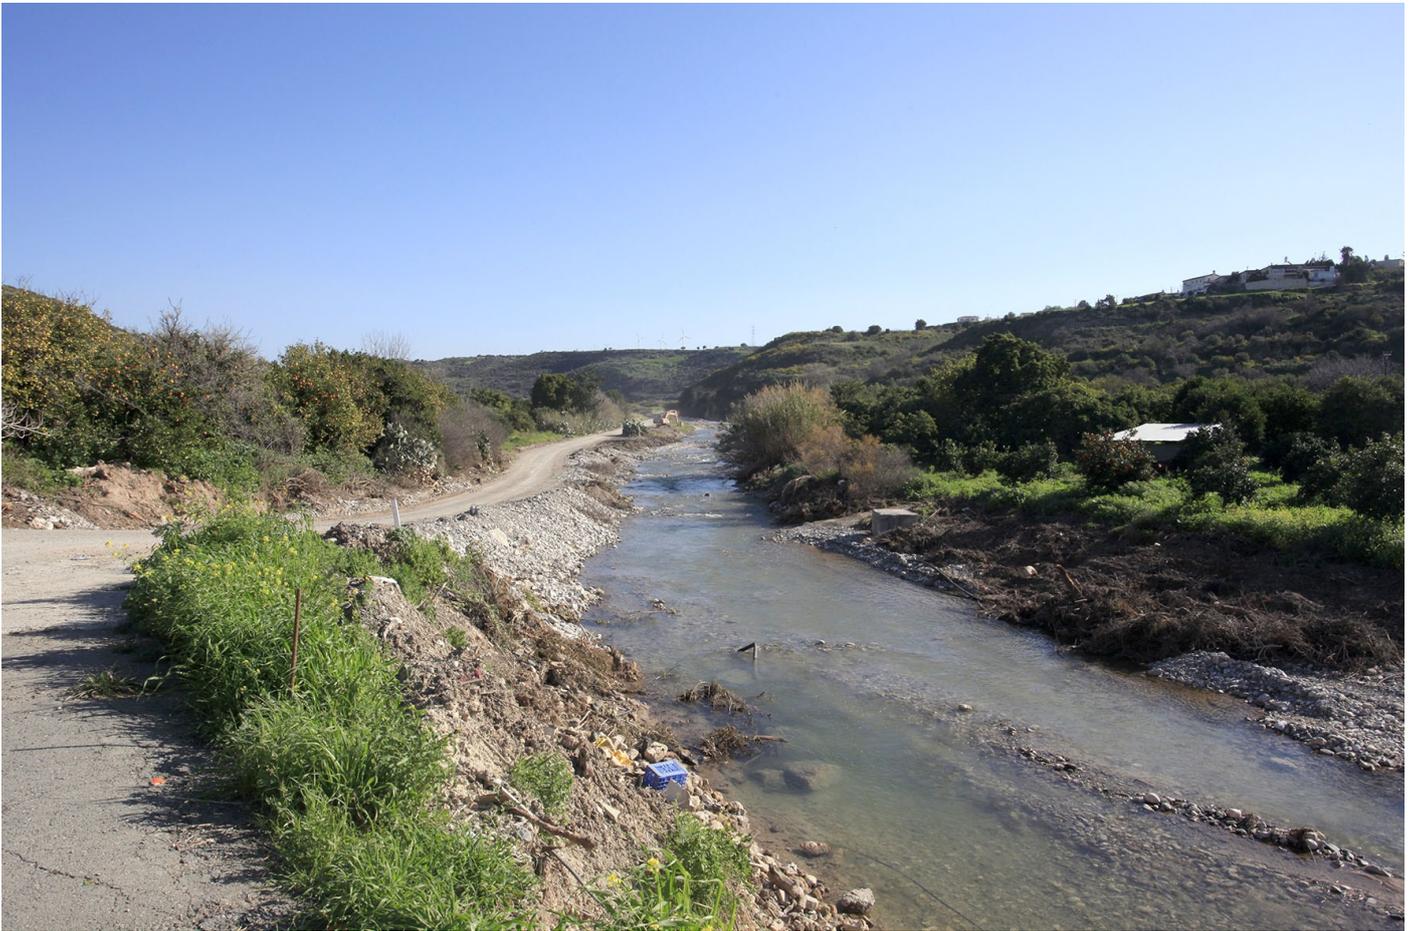
In 2012, after several wet winters the Lower Diarizos was a particularly good site with 16 Odonate species being recorded there. In 2013, however, the site had much less water and a track was constructed through it as shown in the photo above. The site then dried up and remained dry until the start of the rainy season in 2018. The photo below shows the site on 24th December 2018. As can be seen it had a little water and some vegetation.

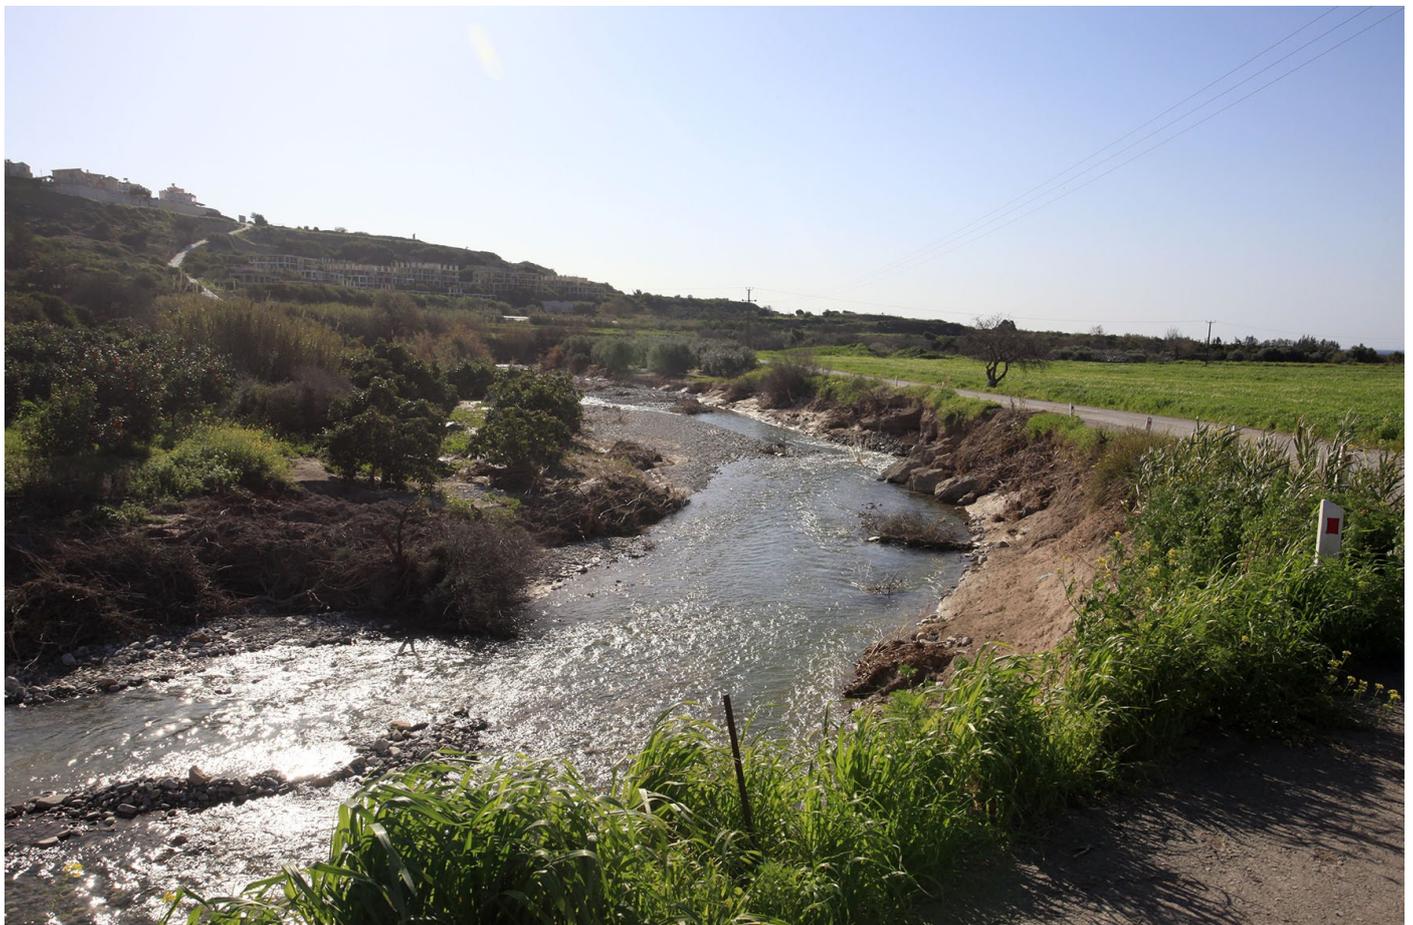
Matt reported on 2nd February that there had been extensive flooding in the valley; that the Kouklia Reed Bed pool had been destroyed and 80% of the road leading to it swept away. As seen in the previous section the pool had indeed been swept away, but when we visited on 5th February the road had been regraded and the Lower Diarizos had been totally transformed by the flood. As shown in the photos above (looking upstream) and below (looking downstream). The vegetation had been swept away and a wider channel along the previous course carved out. There was now a strong flow on a wide stream.
